Full Facility Roof Report

Prepared for:

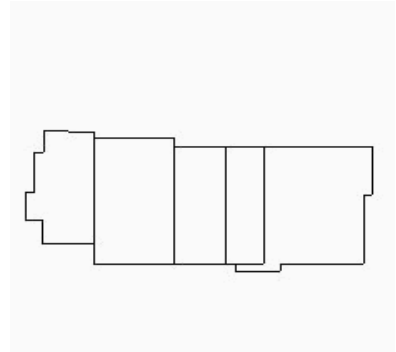
Type of Neighborhood: Urban

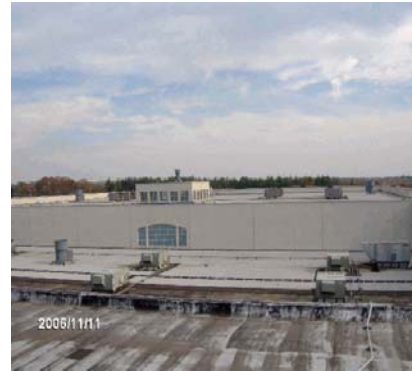
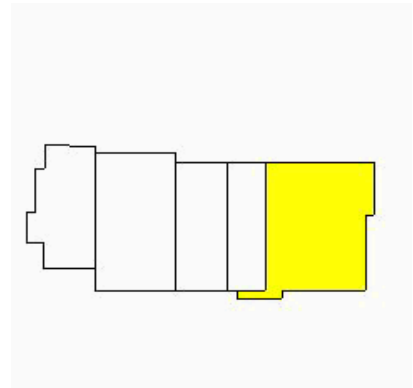
Existing Roof System Construction

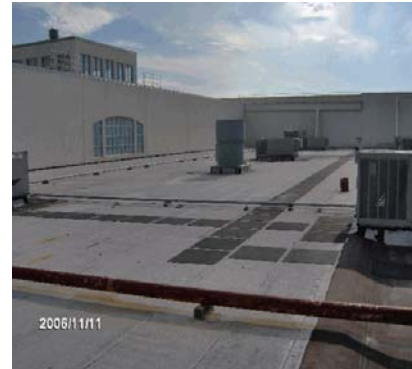
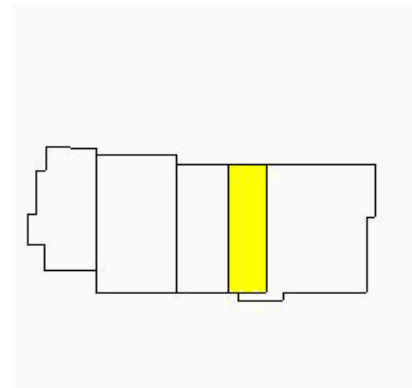
Existing Roof System Construction

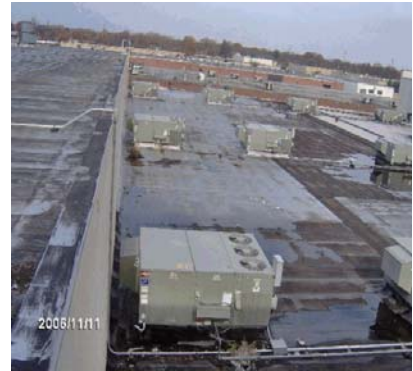
Existing Roof System Construction

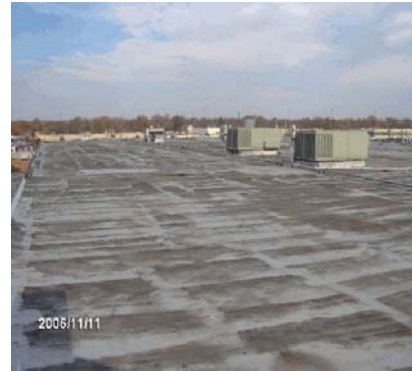
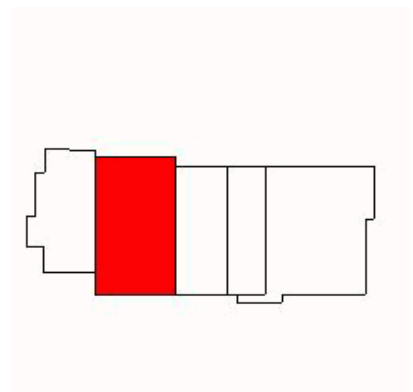
Existing Roof System Construction

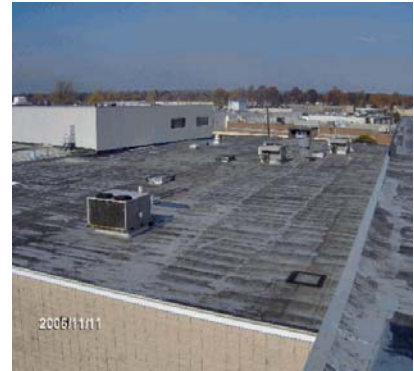
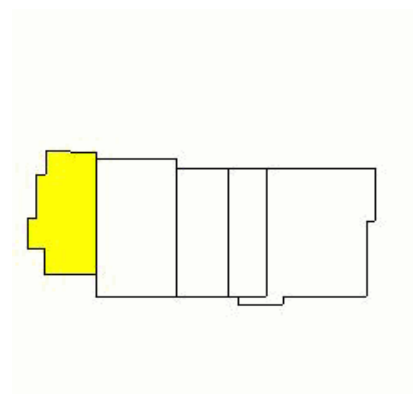
Existing Roof System Construction

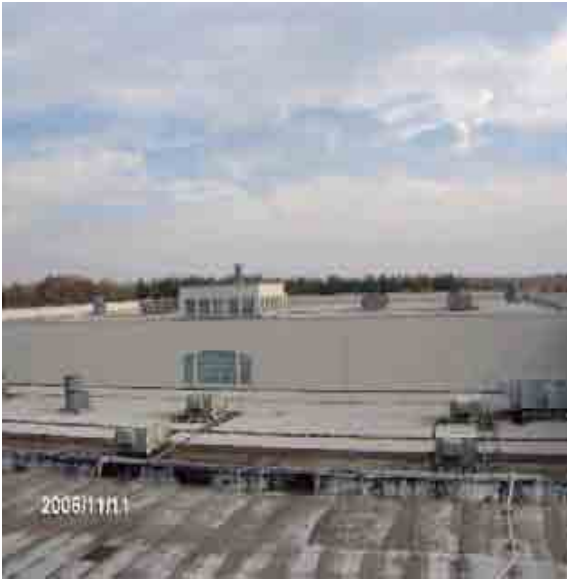
Roof Section 1
The high roof is in the distance.

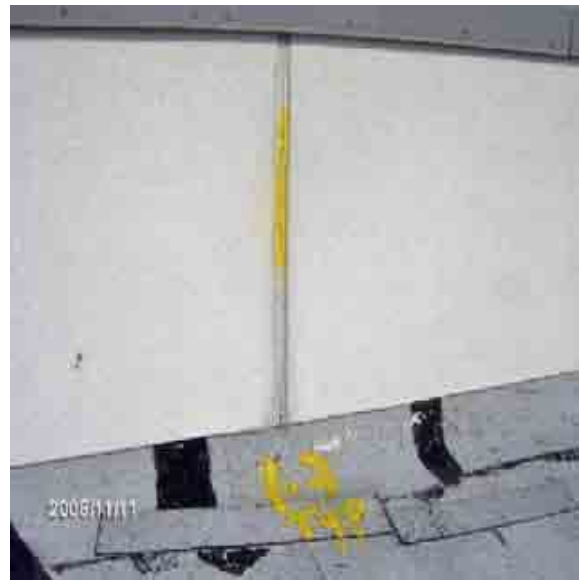
Roof 1-3
The wall joints are deteriorated.

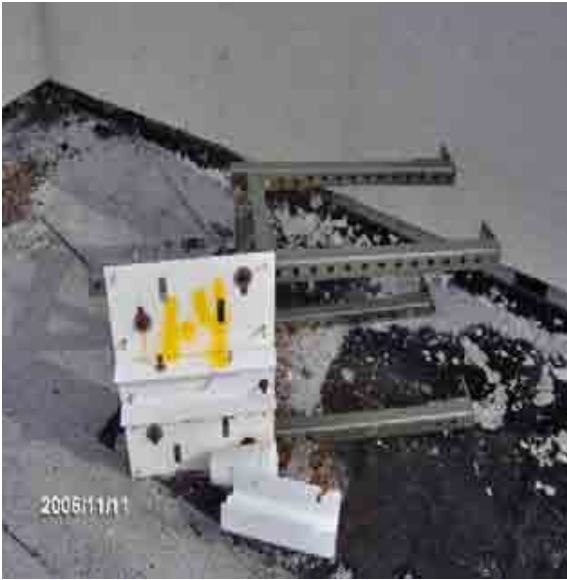
Roof 1-4
Metal debris will puncture the membrane.

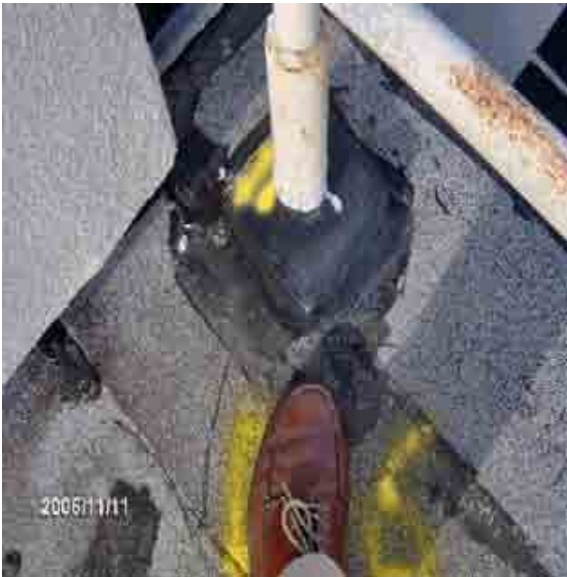
Roof 1-6
The penetration pockets are all in poor condition and should be topped off and a hood added.

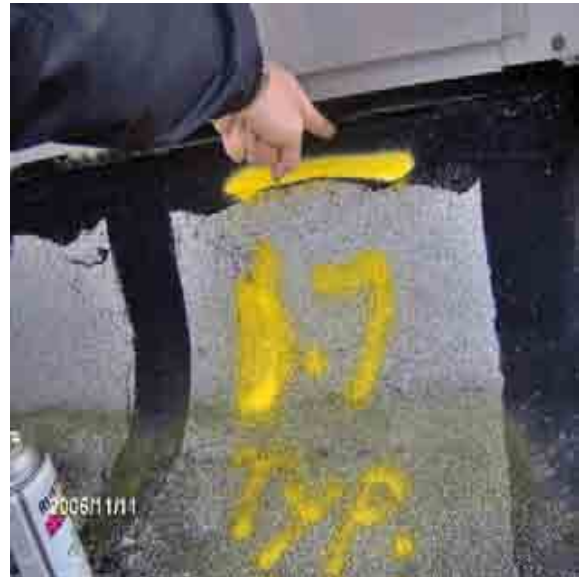
Roof 1-7
The base flashing needs to be properly terminated and have counter flashing installed.

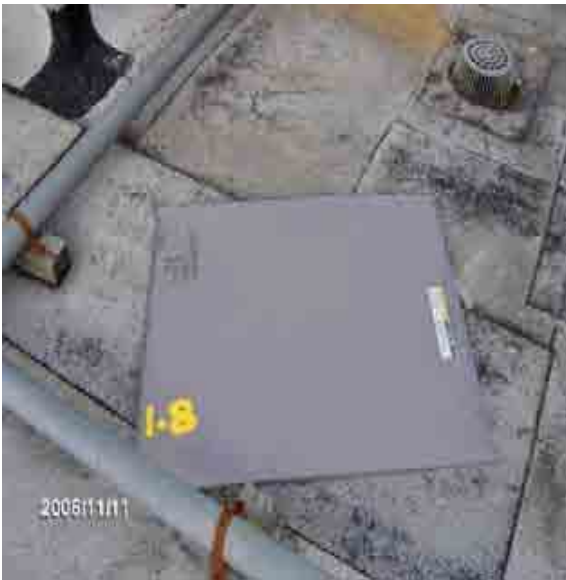
Roof 1-8
Metal panels and debris can become airborne and cause damage to the roof or pedestrians.

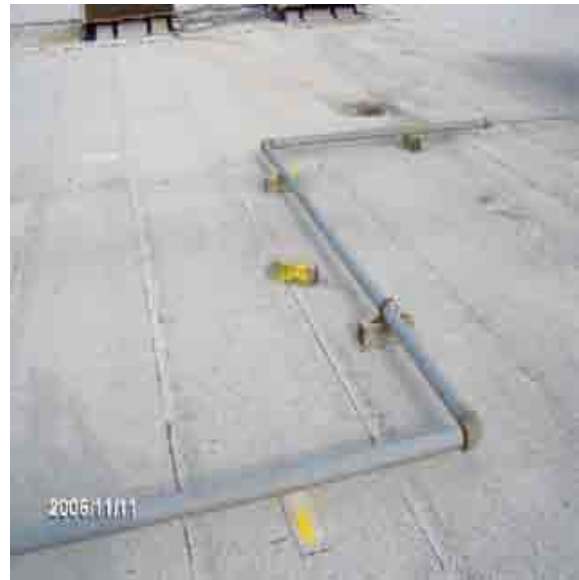
Roof 1-9
Wood blocking should be secured to the pipe. Protection pads should be installed under all wood blocking.

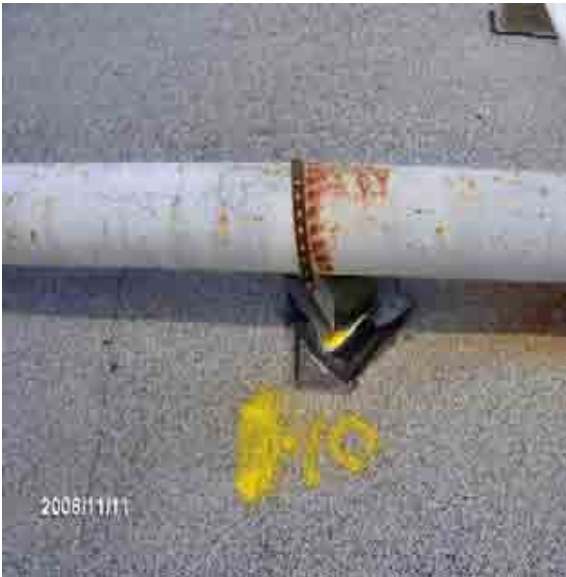
Roof 1-10
This wood block has damaged the membrane.

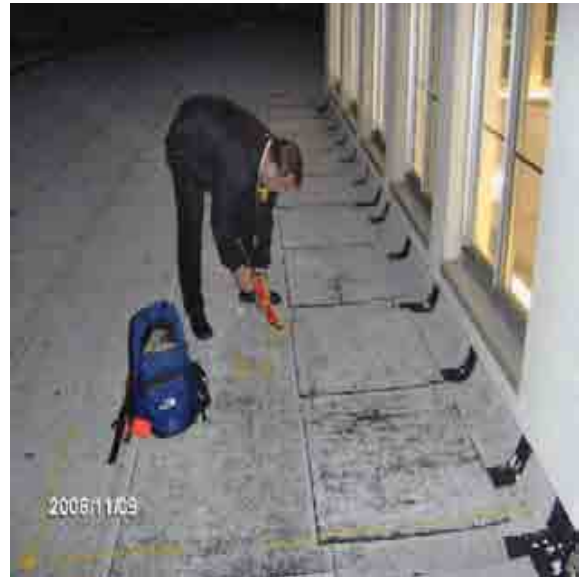
Roof 1-11
A hole was discovered in the roof membrane and was temporarily repaired by Roof Solutions.

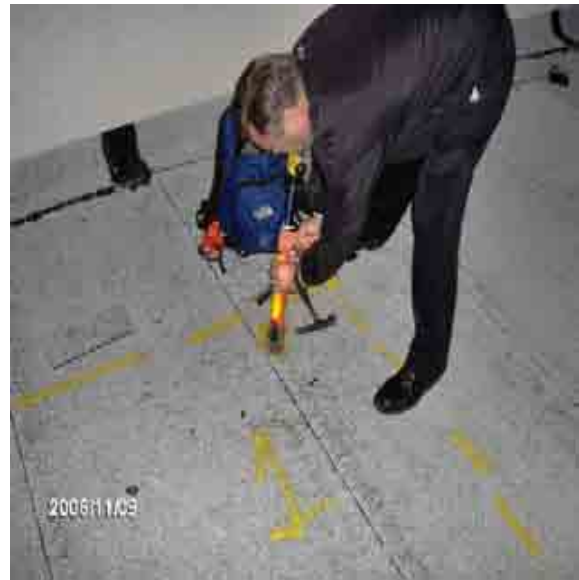
The infra-red camera has detected moisture in the system as seen in the lighter area. This corresponds with the hole repaired in the photo above.

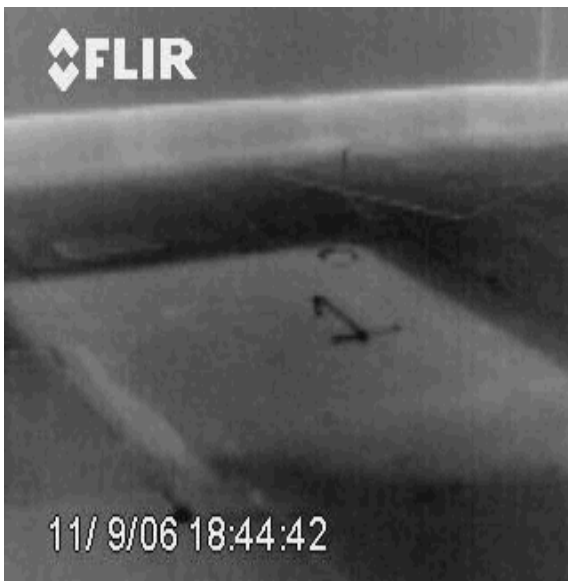
A temporary repair completed by Roof Solutions.

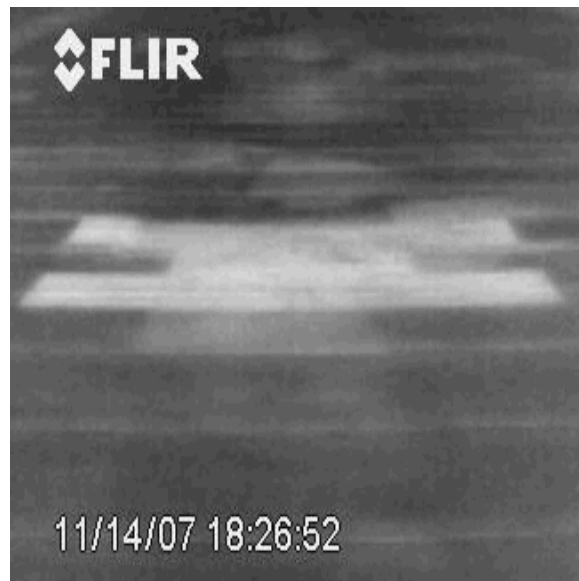
This wet area was detected with the infra-red camera. This corresponds with the repair shown in the previous photo.

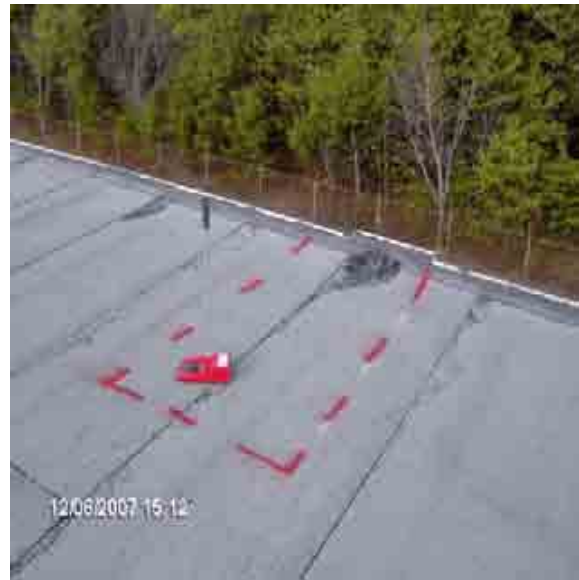
Roof 1-17
The capacitance meter registered moisture in the insulation.

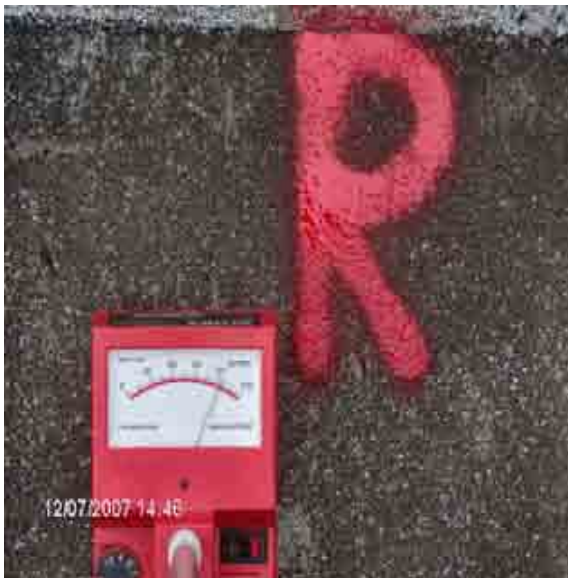
Roof 1-18
Moisture was registered on the Tramex/Capacitance Meter.

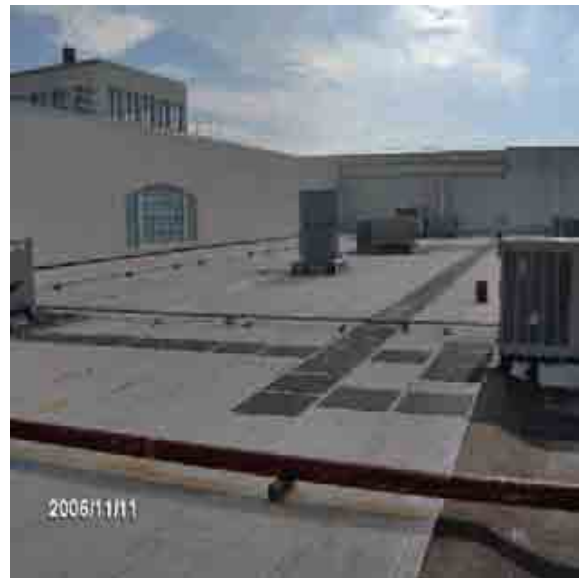
Roof Section 2
Overview of this roof section. Roof 1 is the high roof to the left.

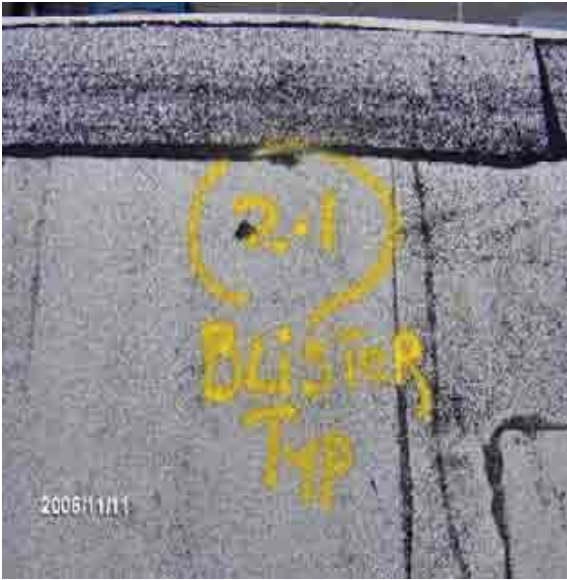
Roof 2-1
Blister was observed and marked. These should be monitored.

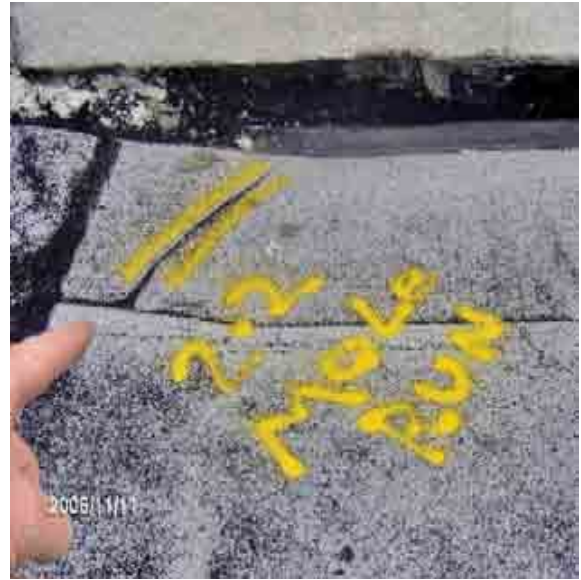
Roof 2-2
This mole run should be cut open and patched.

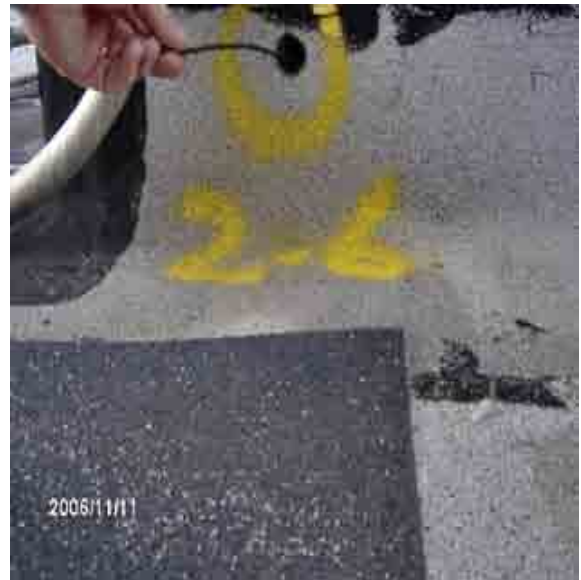
Roof 2-6
Improper flashing. The hole is open.

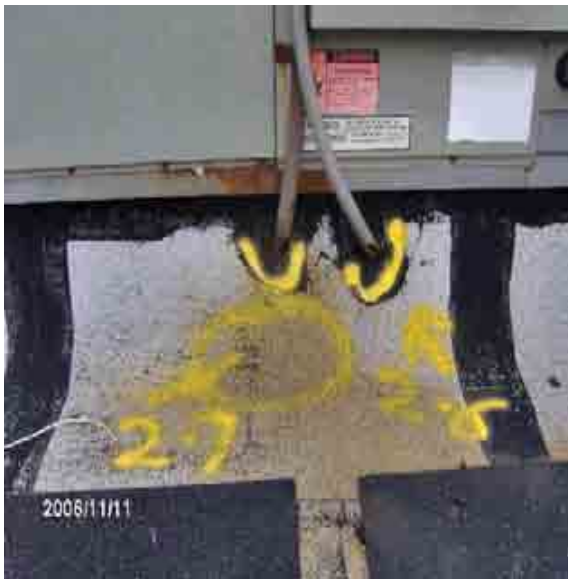
Roof 2-7
Open conduit flashing. Conduits should not be installed through the side of the curb wall.

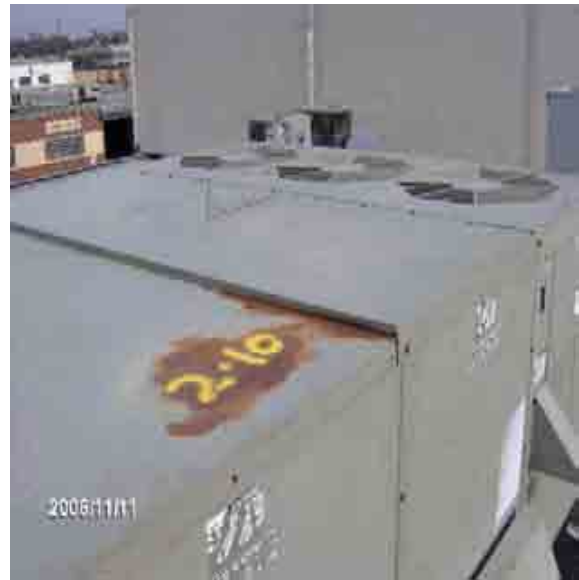
Roof 2-10
The seals are failing. These types of conditions should be monitored.

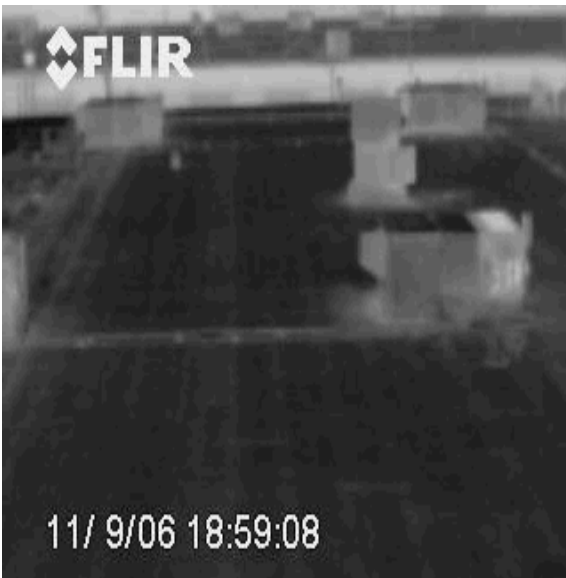
Roof 2-11
This is an infra-red overview of Roof 2. No anomalies were discovered.

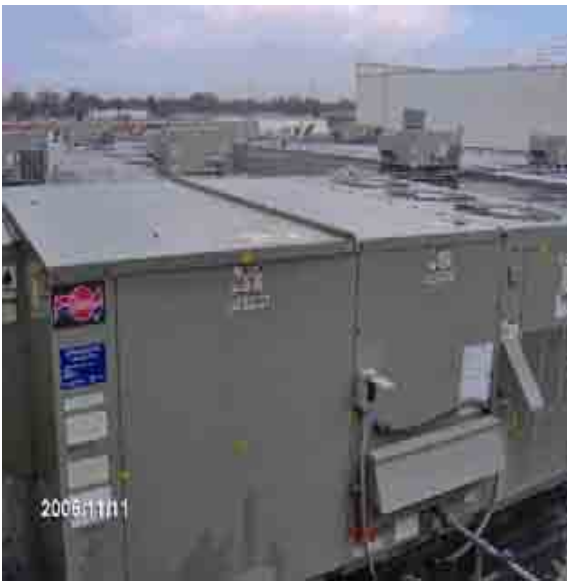
Roof 3-1
HVAC units. These units have failing seals, missing fasteners and screw.

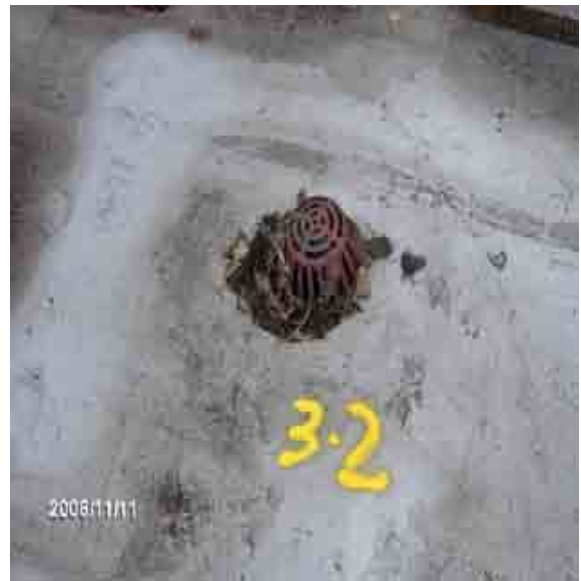
Roof 3-2
Drain strainer not attached. Clean debris.

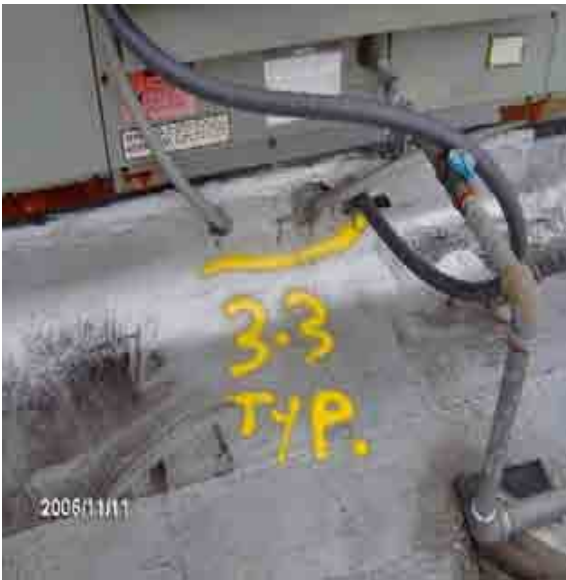
Roof 3-3
Improper conduit flashing.

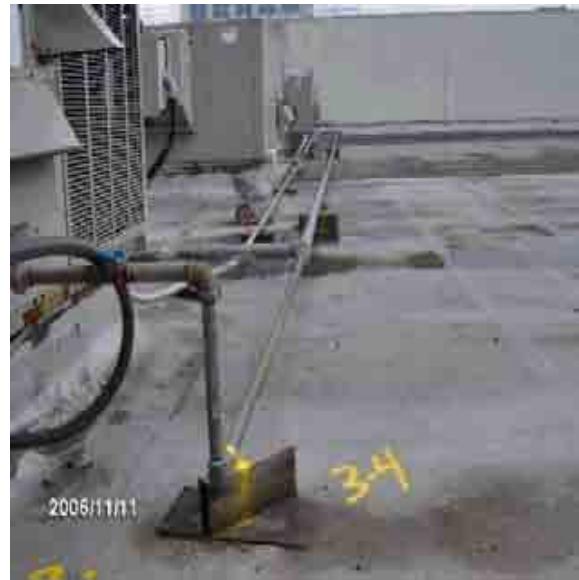
Roof 3-4
Attach all wood blocking with straps.

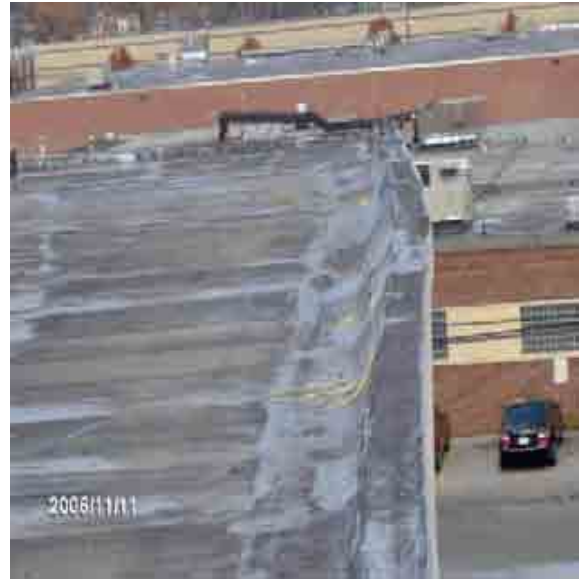
The vertical seams are open. The membrane has pulled away from the wall.

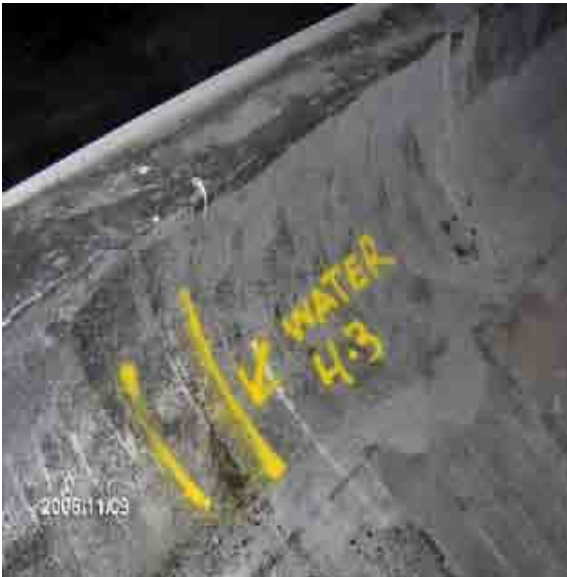
The wall is bowing out in the same area as the two previous photos. This is a serious condition and should be further investigated and corrected.

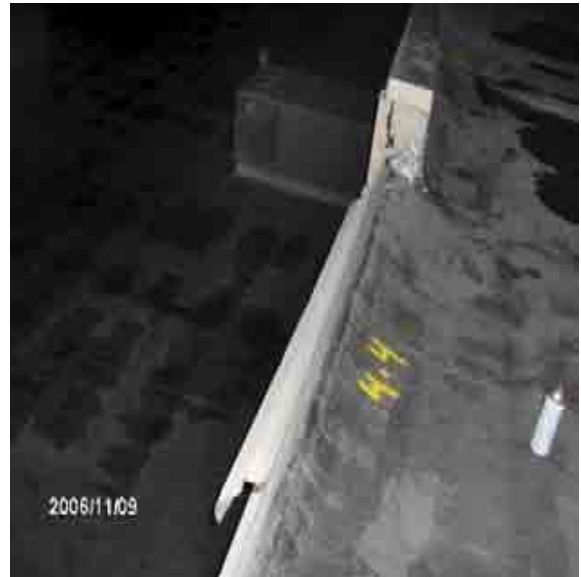
Water is coming out of this split seam.

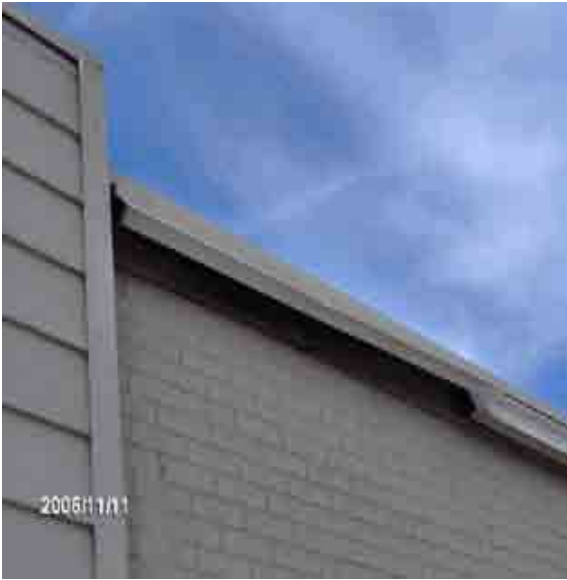
Roof 4-4a
This is the metal as seen from below.

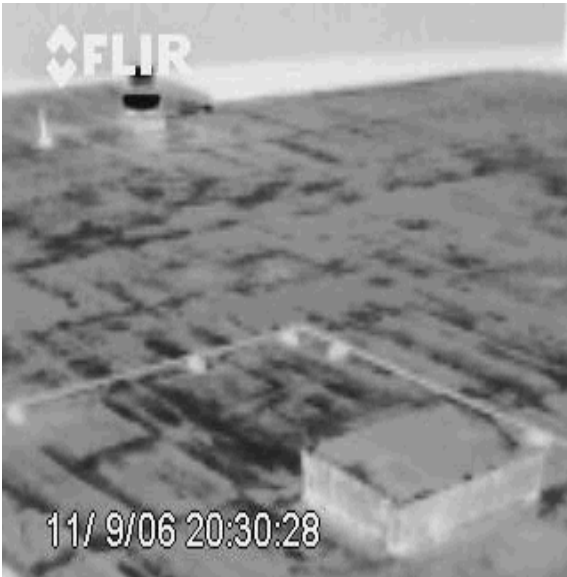
Roof 5
Infra-red overview of Roof section 5. No wet areas were observed.

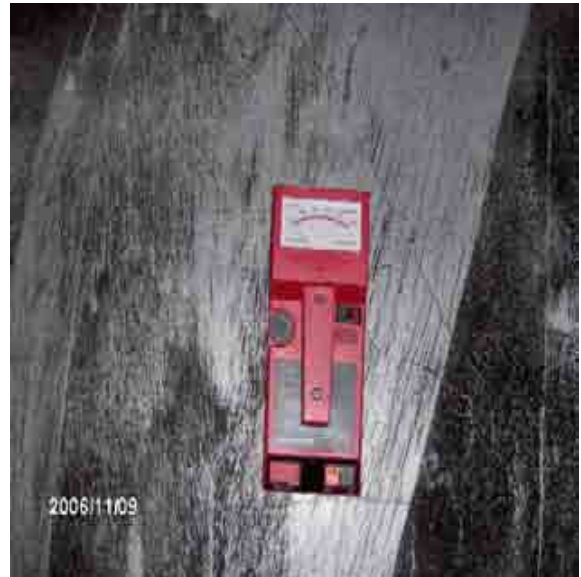
Roof 5
The roof was also checked with a capacitance moisture meter.

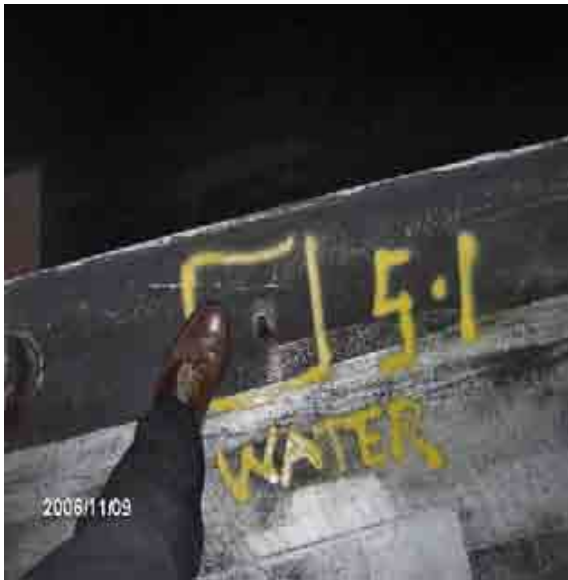
Roof 5-1
Water was found along the edge at this hole in the membrane.

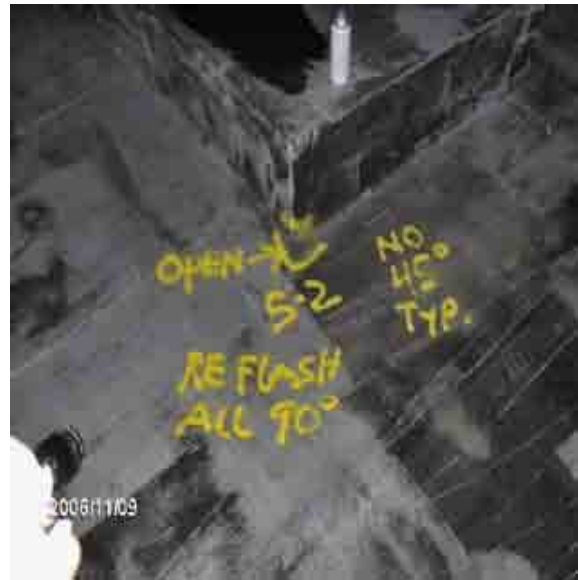
Roof 5-2
Reflash all 90 degree angles on the penetrations.
